June 2022 Volume 33 No 12 Issue 372 A 100% NMRA Affiliated Club

PJW 30700 Well Wagon

July 2022 Volume 34 No 01 Issue 373 A 100% NMRA Affiliated Club

August 2022 Volume 34 No 02 Issue 374 A 100% NMRA Affiliated Club

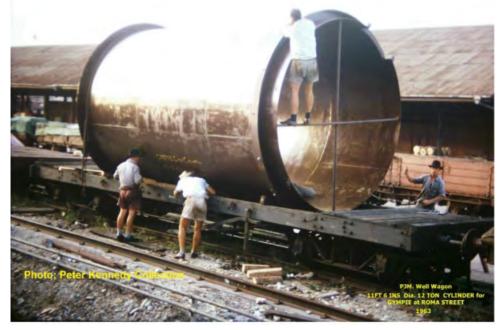
PJM 18536 Roma Street, 24 Road, 11' 6' dia. cylinder for Gympie.1963.

The recessed floor was 6 feet nine inches wide and was strengthened by two steel beams under the wagon frame. The wagon could carry 22 ton 4 cwt. The photo below shows the wagon being loaded at Roma Street in 24 Road. I just love the work practices of this era, I'm sure todays CEO's would not be too impressed with them.

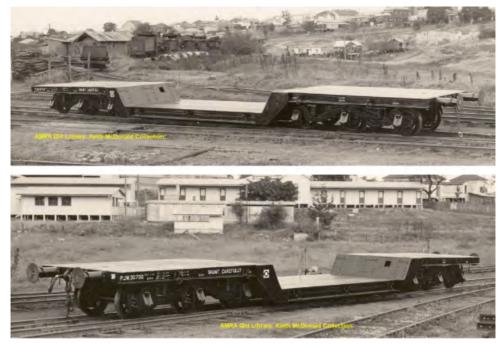
Supports for loads in the well section should be as far apart as possible. When loads are supported on the decking above the bogies, such supports should not be outside the bogie centres. Final location of such loading points was subject to Approval.

Photos AMRA Qld Library, Keith McDonald Collection. The wagon was painted black, in the 1970's painted grey like other steel wagons at the time.

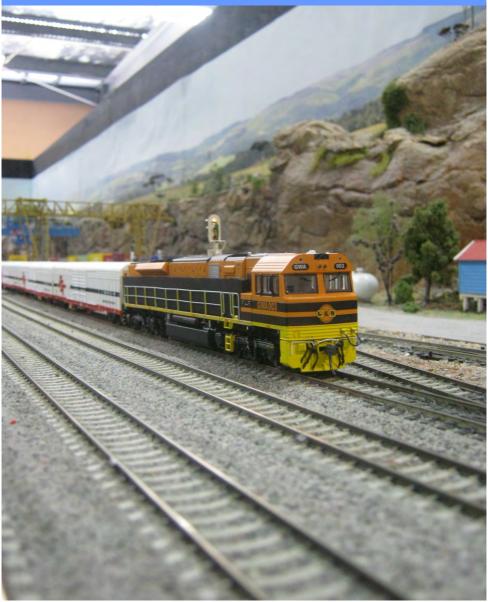
Westgate SWR.

The wagon on the layout was scratch built using styrene.

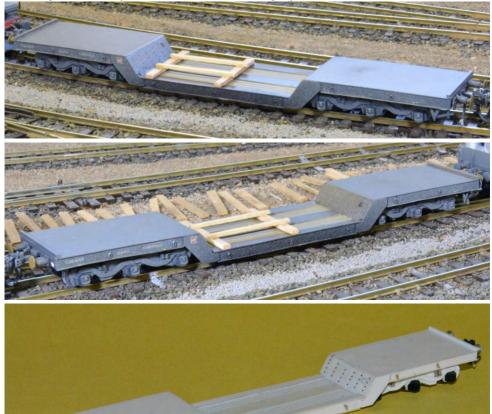
The bogies were also scratch built from styrene, the wheels run in Steam Era bearings.

Axle box covers were cut from retired Roundhouse bogies.

A jig was used to assemble the bogies.

The bogies were mounted off centre to reduce the overhang on curves. The centre wheelset has extra side movement

for the curves. The coupler pocket was built into the frame giving the end wheels extra clearance. Plumber's lead sheet was packed into the well section and on the

slop section. This gives the wagon a low centre of gravity and tracks very well on the layout.

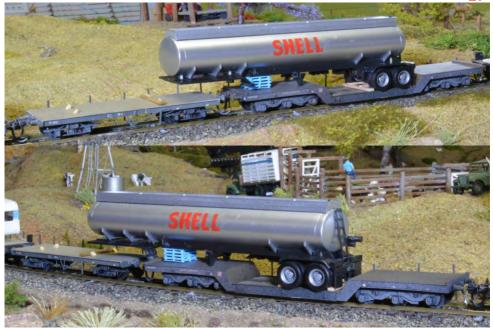
The load on the wagon is not secured with securing equipment and blu tack is used to keep the load on the wagon. The main reason for this to allow me to change the loads and run the wagon empty. This relates back to my March 2019 blog "What's on our Trains".

The road tanker is a Herpa Elliptical Gas Tanker Trailer. Shell decals were added. After purchasing the tanker a tri axle vehicle was available.

The runner wagon is a scratch built 26 ft. "P" wagon, securing timbers from a previous load are still on the wagon.
