The Queensland cottage - with its overhanging roof and wide verandahs - is a basic type well suited to the tropical and semi-tropical climate. Its most obvious variation is the roof style, with cottages of very similar floor plans looking quite different due to varied roof shapes. The accompanying photos show several variations and alternative details.

enland Cottage

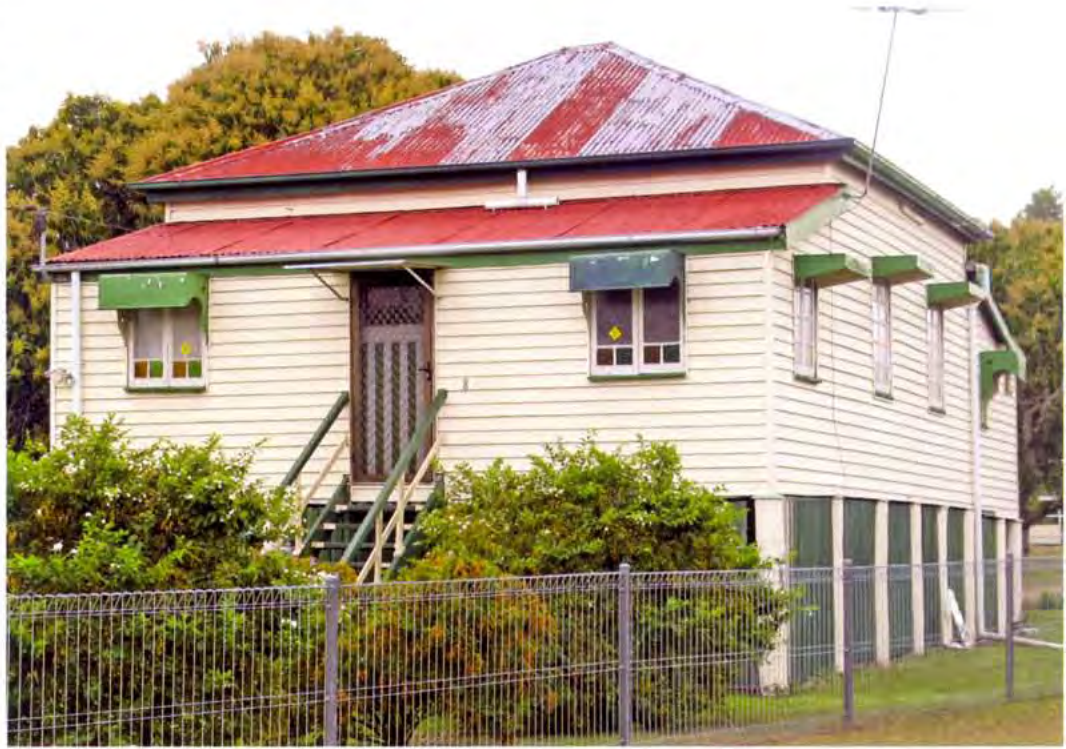
RIGHT: A well maintained medium high-set cottage with a pyramid type roof, indicating that the main part of the building is square or close to square. Both the front and back verandahs have shed type roofs and the metal window awnings are quite basic. The weatherboard coverage on the side of the house indicates the front verandah was enclosed when the exterior sheathing was first applied, but that the back may have been finished later. The stained (coloured) and frosted glass of the multi-pane sleep-out windows is a common feature of such dwellings. In all cases the largest windows appear to be outward (centre) opening case-type.

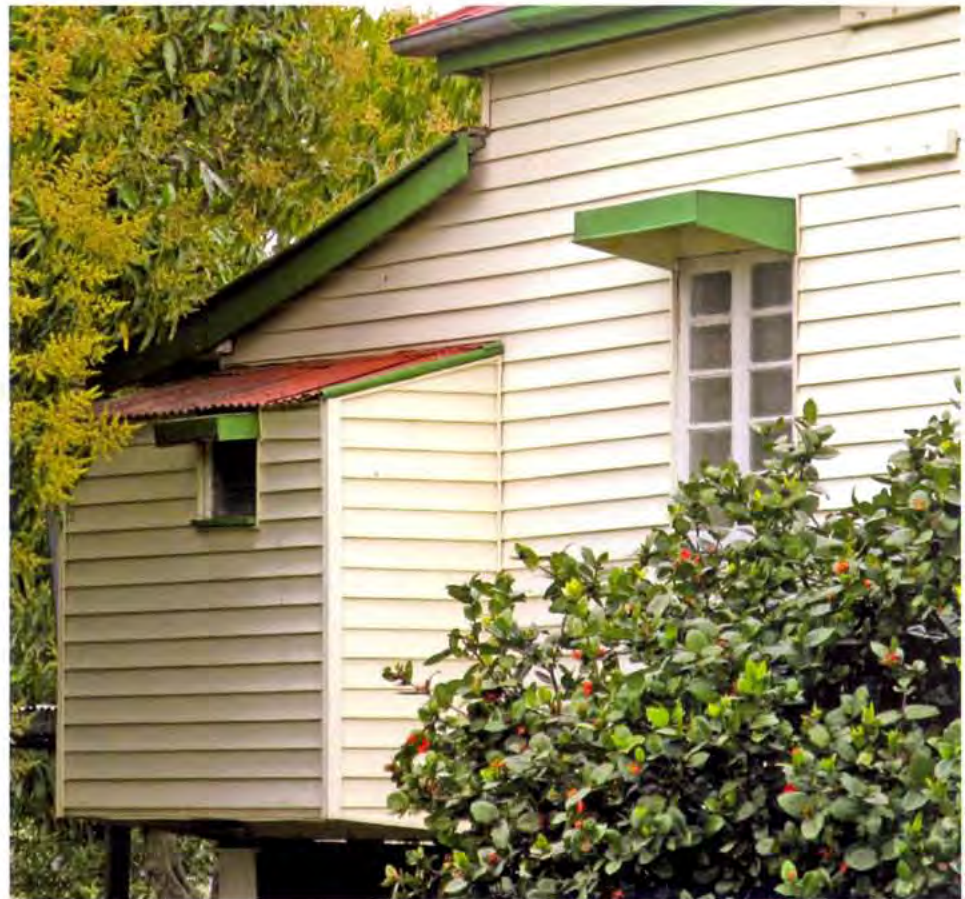
RIGHT: The far back corner of the same cottage showing a timber framed enclosure extending from the back verandah. Since there is no obvious chimney or plumbing pipes this is likely a replacement for the original sheet metal kitchen enclosure. The placement in this end of what was essentially a back verandah suggests that the toilet might be located on the other end of this verandah, perhaps in a similar extension.

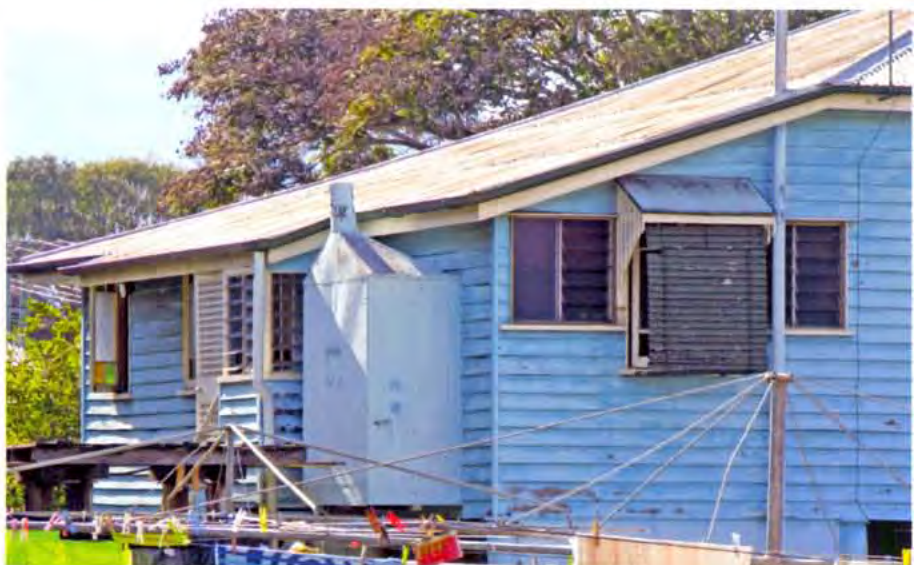
RIGHT, TOP: The rear of this enlarged cottage has a verandah that was likely enclosed at the same time as the dwelling was sheathed with weatherboard, and a further extension over the rear door in the centre of the back wall.

The original metal stove enclosure retains its smoke stack but this has probably been blocked to prevent rainwater entering. The windows and louvres have likely been added at different times and the hanging shade would seem to provide little protection from the summer sun. The roof on the main part of the dwelling is a modified pyramid type.

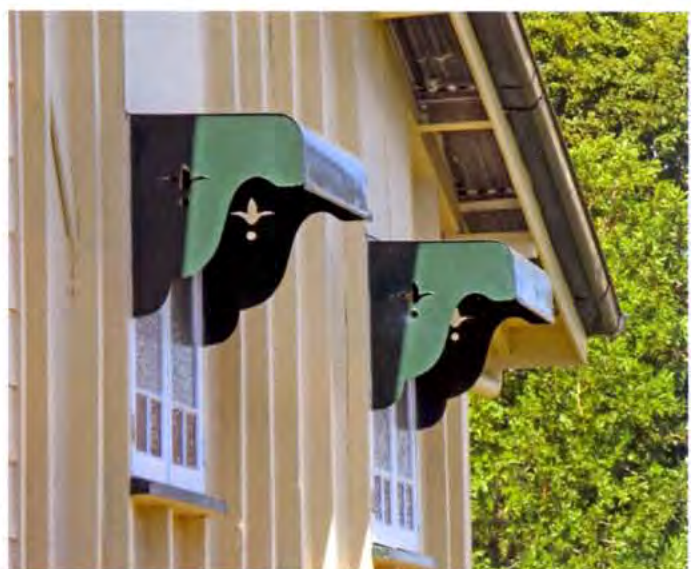
MIDDLE: While the front of this cottage has been sheathed with weatherboard, the back half still has exposed stud walls. Note the sheathing above the window awnings that keep water from getting behind the awning and into the cottage.

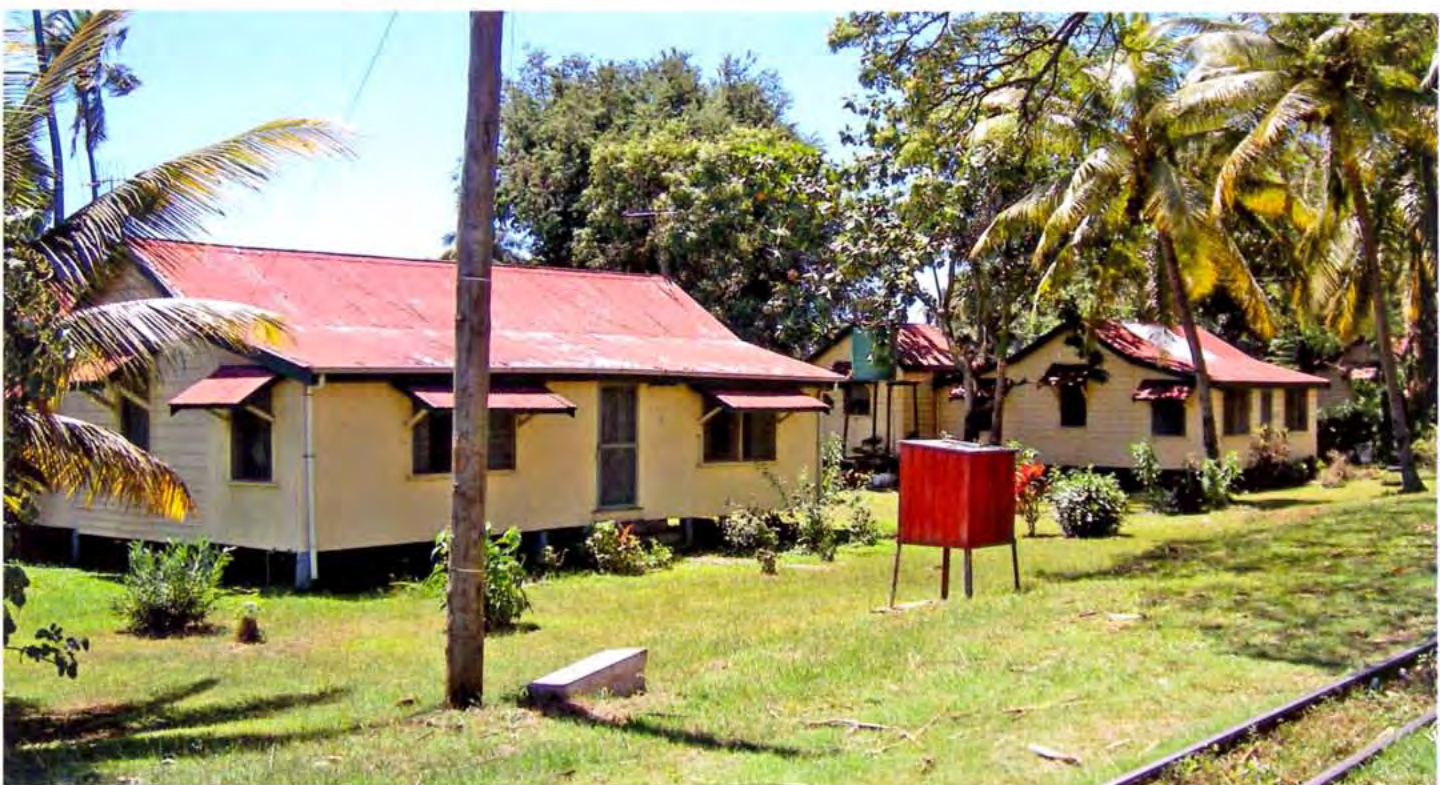
BOTTOM: Fiji Sugar Corporation (originally CSR) staff quarters in Lautoka have construction similar to Queensland, and show how closely dwellings were built to the cane railway mainline.

The verandah on the closest cottage has been enclosed with vertical V-joint timber; the far cottage verandah uses horizontal weatherboard, but 'cement board' sheets (often containing asbestos) could also have been used. The window awnings are lightly framed corrugated iron, and on upscale buildings might even be hinged to serve as rudimentary shutters in case of a cyclone.

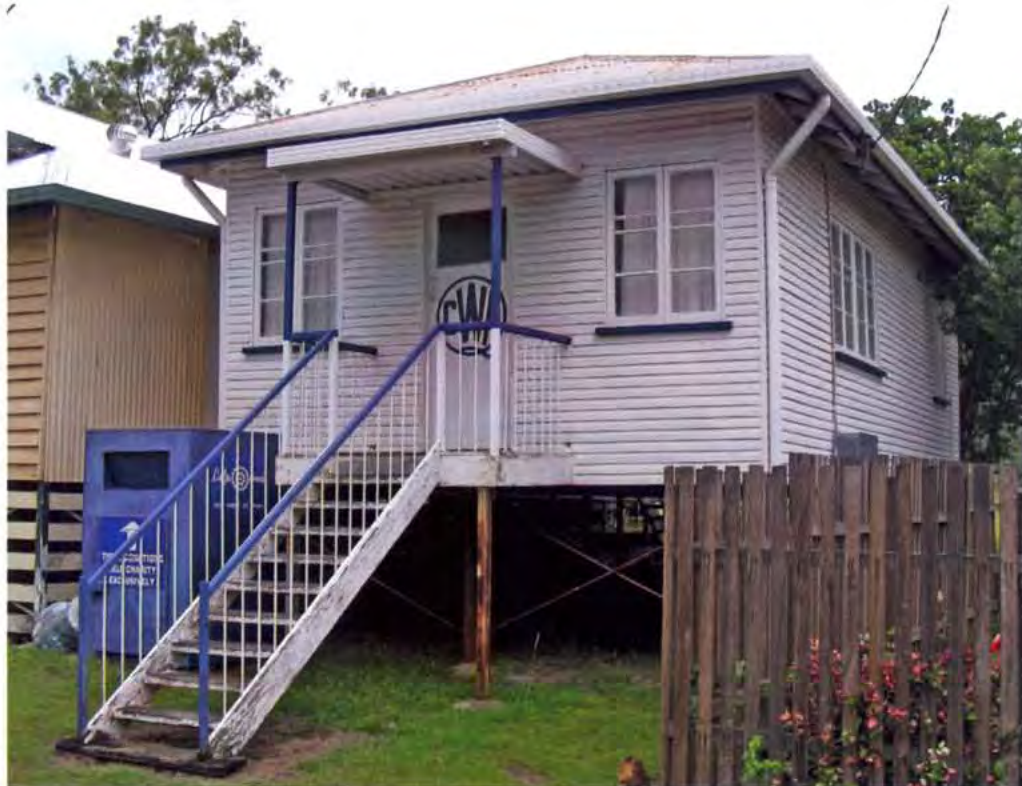
RIGHT, TOP: CWA (Country Women Association) cottage at The Caves, Queensland. The roof is a modified pyramid, the cottage being longer than it is wide. The back door is offset from the centre and if there was a stove extension, it was removed at some time in the past.

The narrow siding is a 'novelty' board with routed edges so that it sits flat, rather than at a slope. The front door covering is in lieu of a verandah. The cottage would originally have been constructed with timber stumps, probably much lower than the replacements.

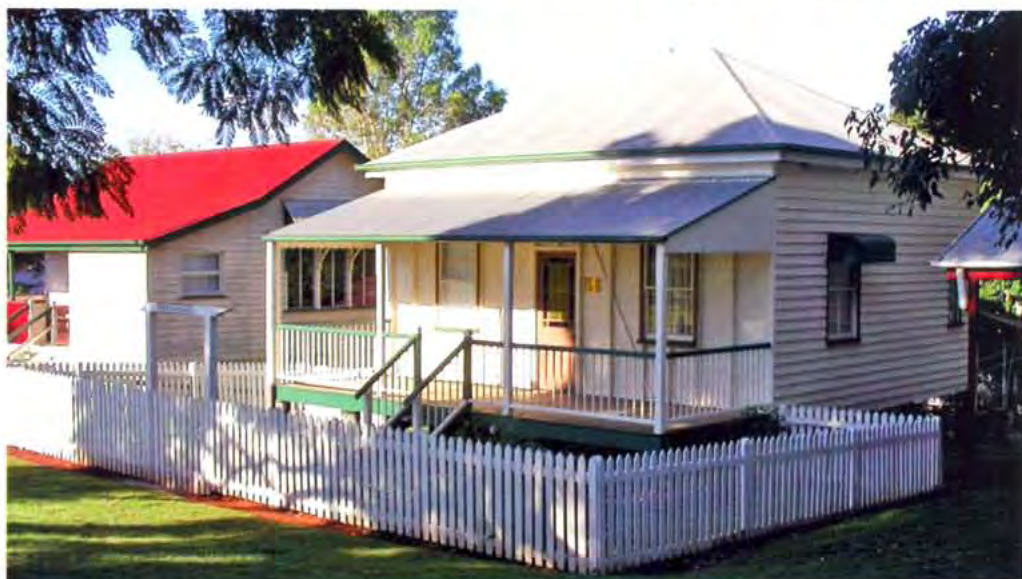
MIDDLE: Mill Cottage, with a full width verandah and railing, donated by the Isis Central Sugar Mill to the Childers Historical Complex. The side of the verandah roof was the model for the cottage kit.

The smaller cottage in the distance has a partially enclosed verandah and sleep-out similar to the kit.

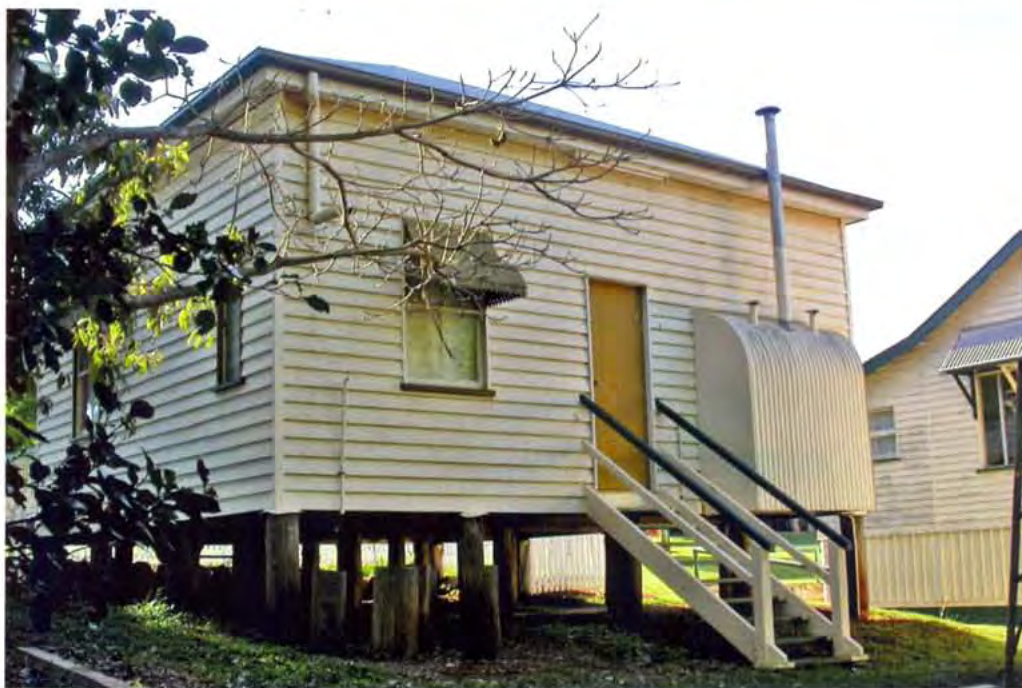
RIGHT: Rear view of the Mill Cottage showing the height of the ceiling and the location of the stove extension.

The double curve of the rear window awning is quite different to the side awnings visible in the front view.
